ENGINEERING GEOLOGICAL INVESTIGATION OF
EARTHQUAKE-INDUCED GROUND DAMAGE AND TENSILE
CHARACTERISTICS OF LOESS-COLLUVIUM SOILS,
EASTERN HILLSBOROUGH VALLEY, CHRISTCHURCH

A thesis submitted in partial fulfilment of the requirements for the Degree
of Master of Science in Engineering Geology

at the University of Canterbury

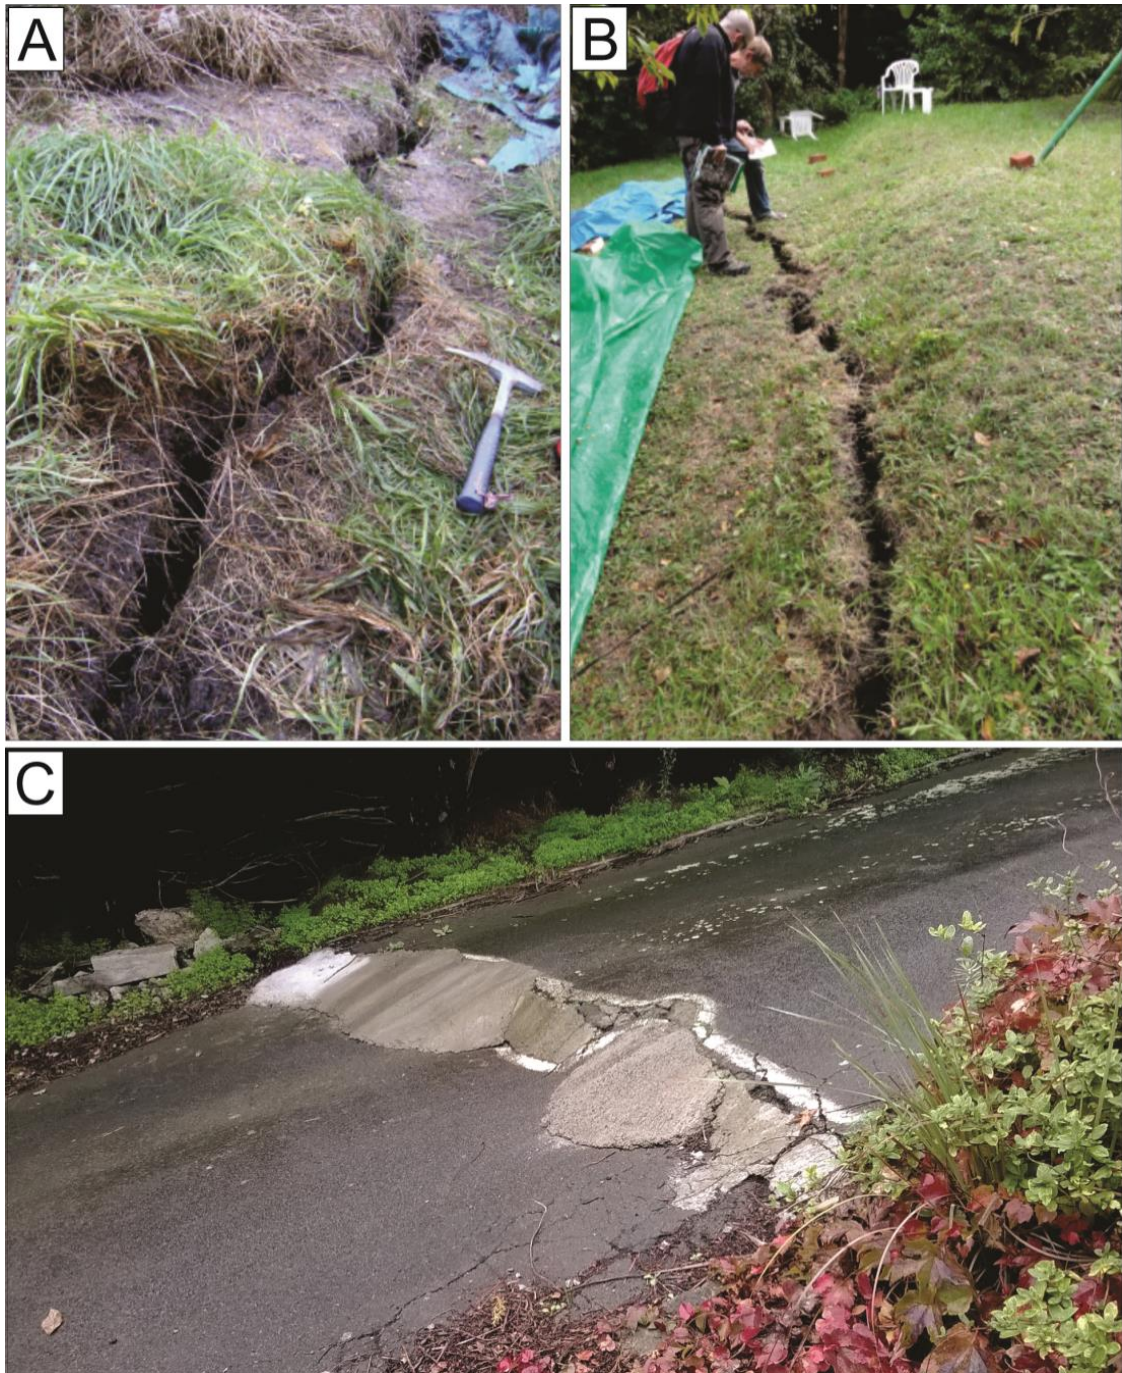
Figure 2.3: Examples of tension cracking in the Vernon Terrace area. A) Stephen Brownie (2012), vertical displacement is $\sim 0.12\text{m}$; B) Dellow et al. (2011); C) Author, vertical displacement is $\sim 0.15\text{m}$.

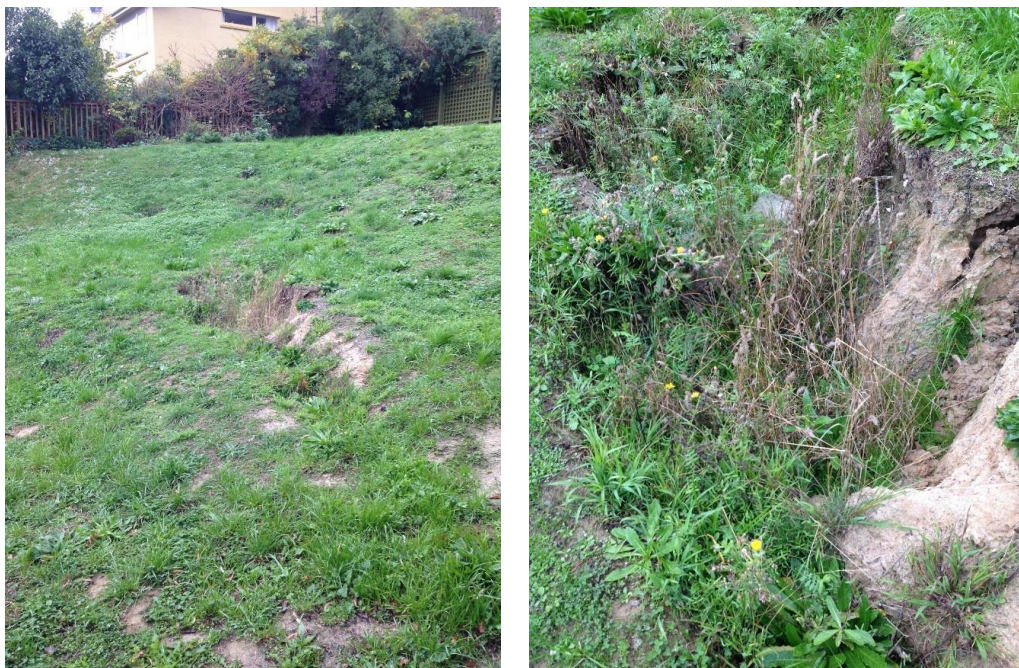
Figure 3.6: View of fissure looking north (left) and close-up view of weathered and infilled section (right), adjacent to the trench.

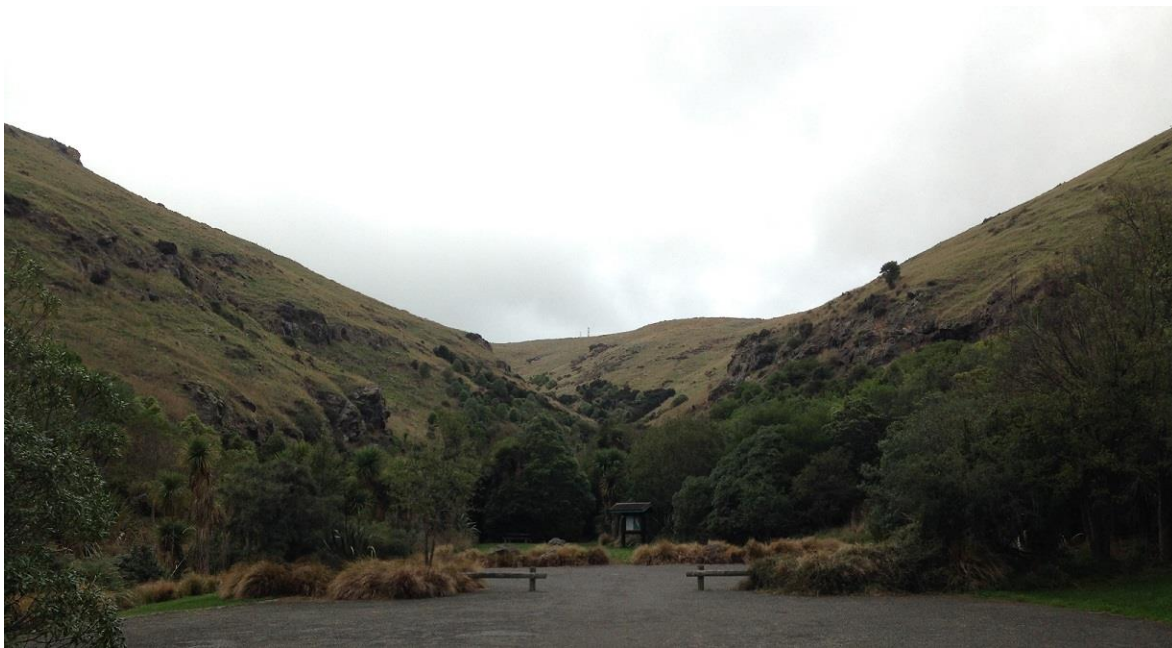
Figure 3.13: View looking southwest from the carpark at the beginning of the Mt Vernon Valley track. Note the steep slopes and rock outcrops. See Figure 3.14 for photo location.

Bedrock consists of Lyttelton Volcanic Group (LVG) basalts, agglomerates and ash (Brown and Weeber, 1992). Flows dip gently to the north, outcropping in the upper reaches of the valley (Figure 3.13), and along the shoulder of Glenelg spur (Figure 3.15). Brown and Weeber (1994) estimated bedrock to be approximately 50m below mean sea level at the northern end of the valley, based on deep drilling in the adjacent Heathcote and Bowenvale Valleys. While depth to bedrock at the centre of the valley is unknown, drilling carried out in mid-2011 encountered bedrock at 44.7m below sea
